USF Report No. 12.22.1304

Building Damage Evaluation

Supplementary Report

**Location of Loss:
Ramey Residential Building
24 Michigan Street
Long Beach, New York 11561-1309**

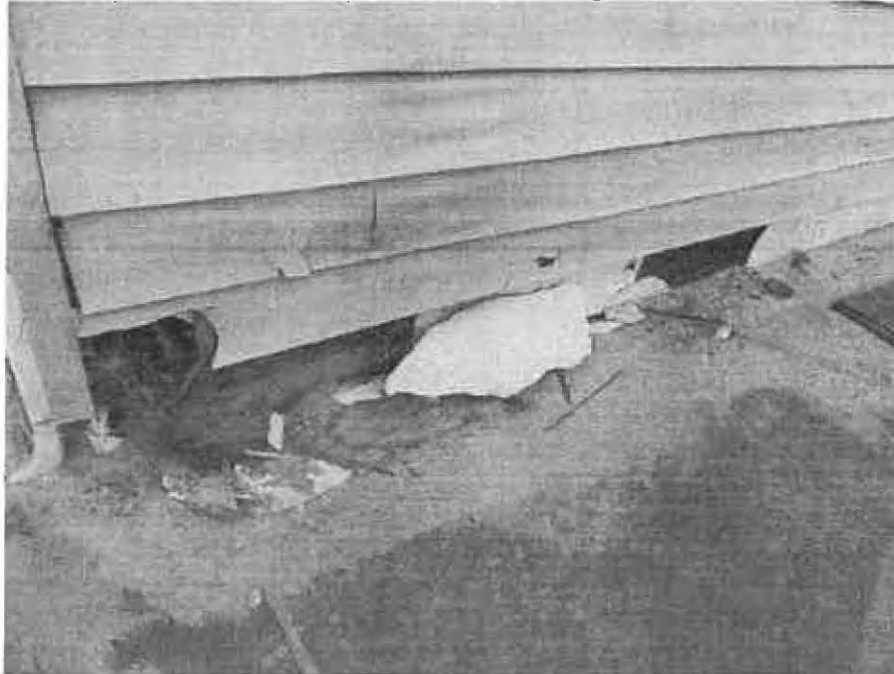
Photograph 1

View of the south-west corner of the building.

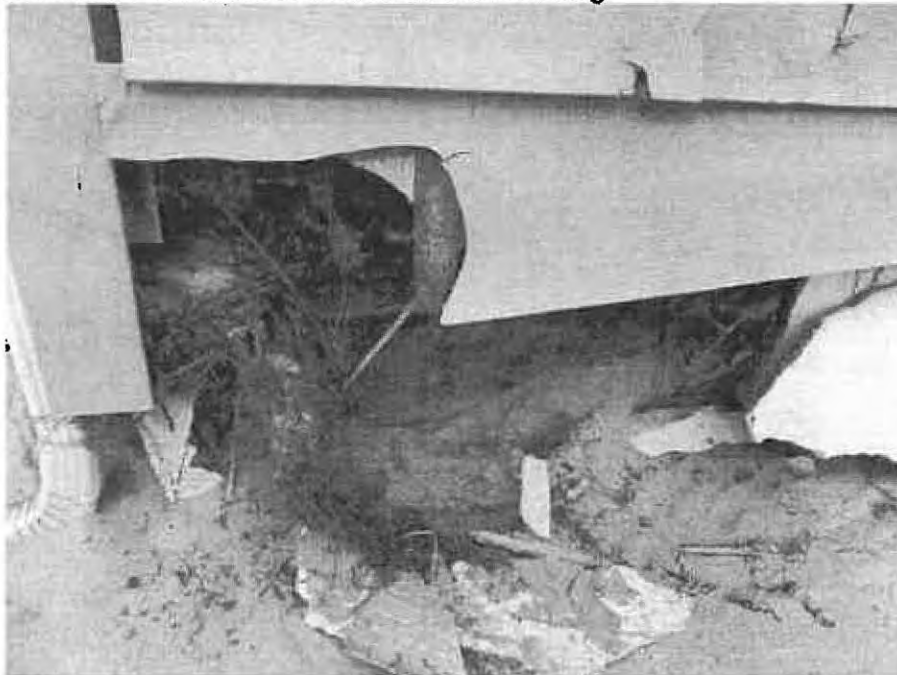
Photograph 2

View of the south-west corner of the building

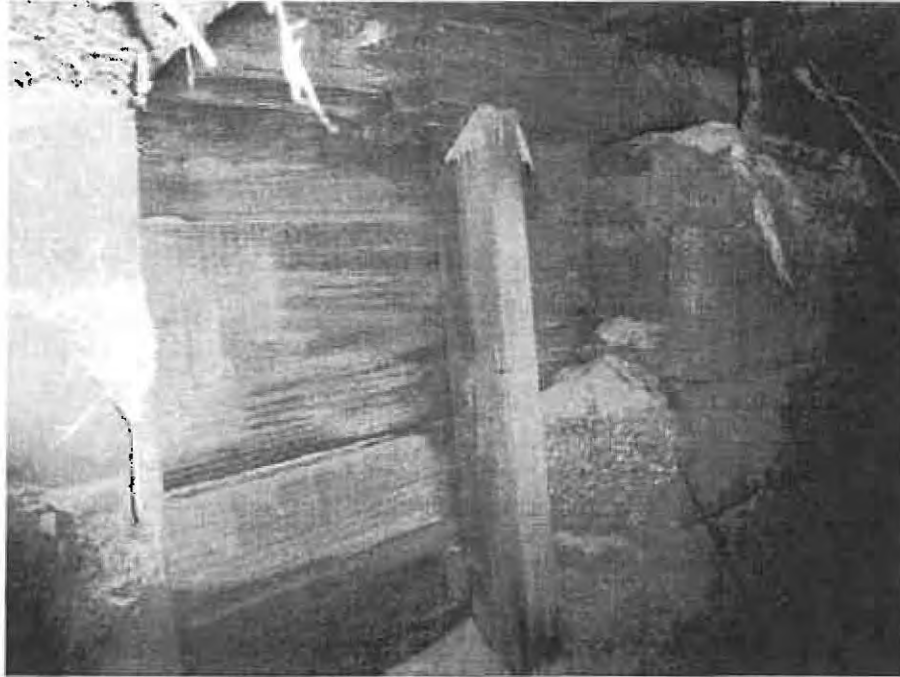
The foundation wall along the west perimeter of the building was noted to be partly constructed of concrete masonry unit (CMU) blocks and partly constructed of wood planks. The regular pattern of supporting piers appeared to be broken in the area adjacent to the south-west corner. On many locations, vertical wooden piers appear to have been successively added to the foundation system.

Photograph 3
View of the west foundation wall.

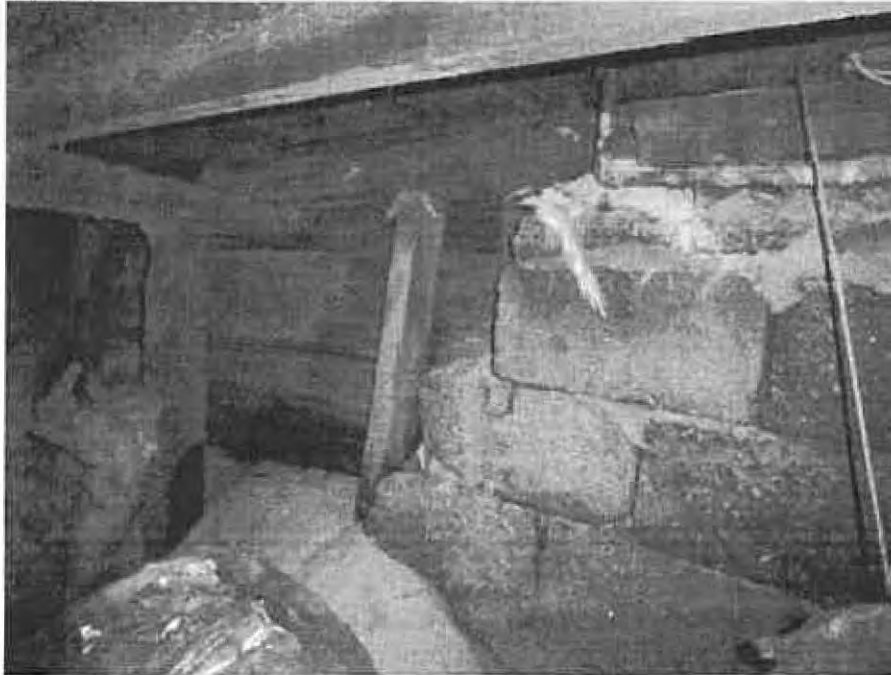
Photograph 4
View of the west foundation wall.

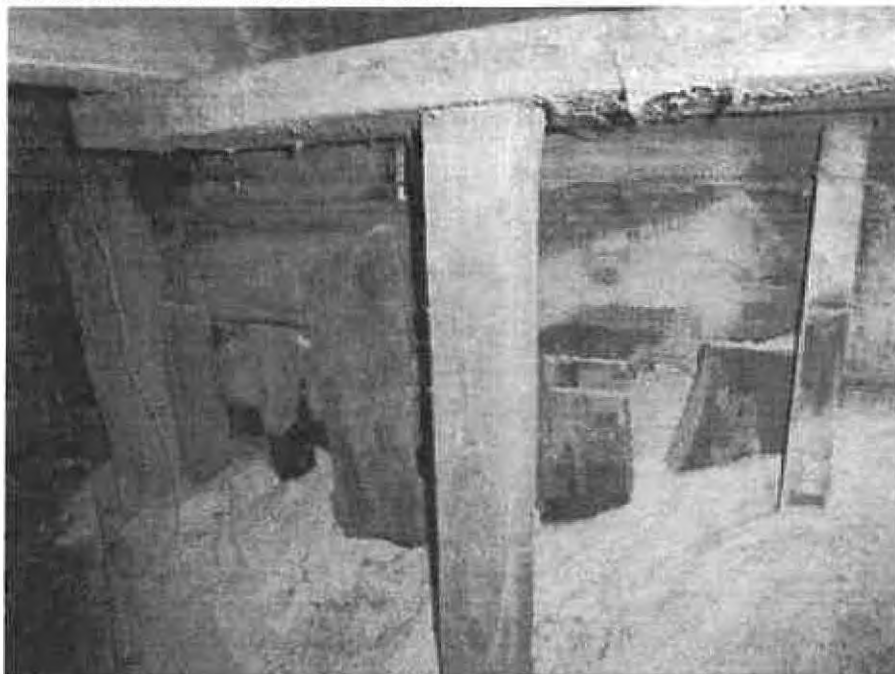
The removal of the water born sand made it now possible to inspect the foundation wall along the south wall. The foundation wall along the south perimeter of the building was observed to be constructed of horizontally lapped wood planks. The outside of the planks was covered with board a layer of stucco. Approximately 10 feet of that stucco siding on the foundation wall on the south side of the building had been damaged.

The evidence observed at the site indicated that the property experienced depth and velocity flow of floodwaters during the subject flood event. The damage of the stucco siding of the foundation wall along the south perimeter of the building was likely caused by the impact of waterborne debris.

Photograph 5
View of the south foundation wall.

In order to repair the damages of the façade siding on the south side of the building, approximately 30 sf of the stucco siding on the foundation wall and the two lowest façade panels (approximately 45 sf) should be replaced

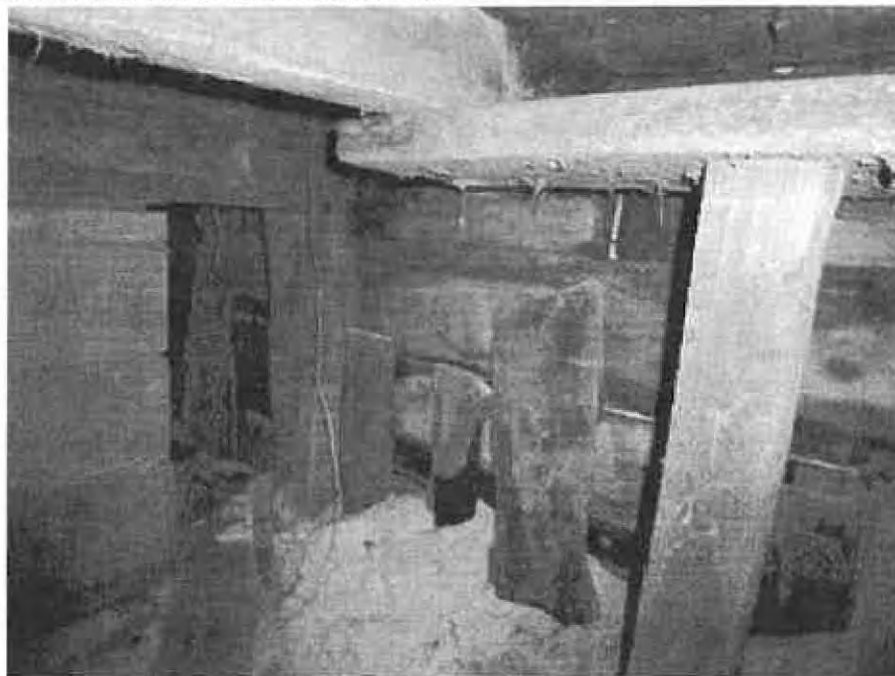
Photograph 6
View of the south foundation wall.

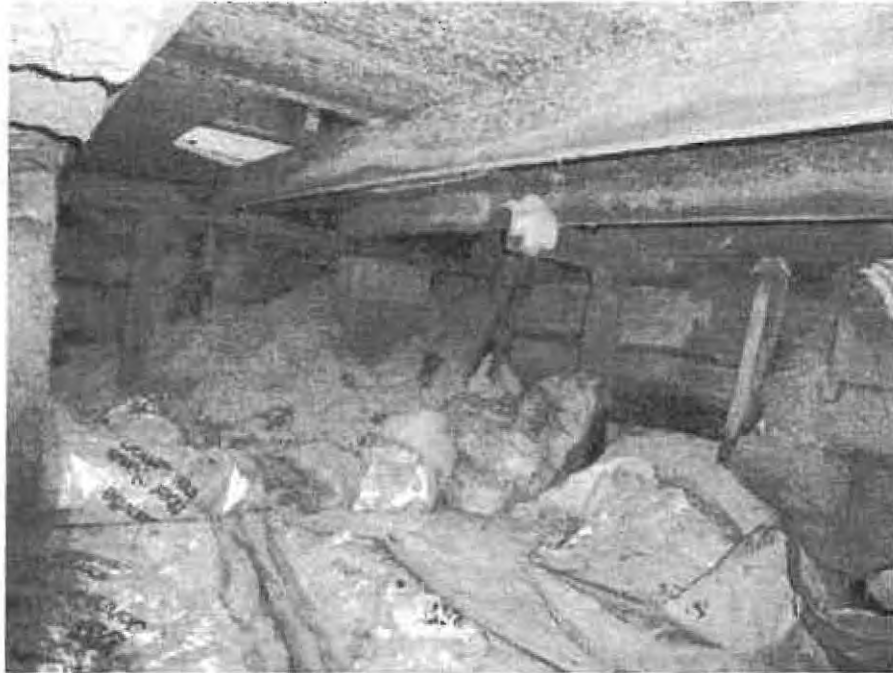
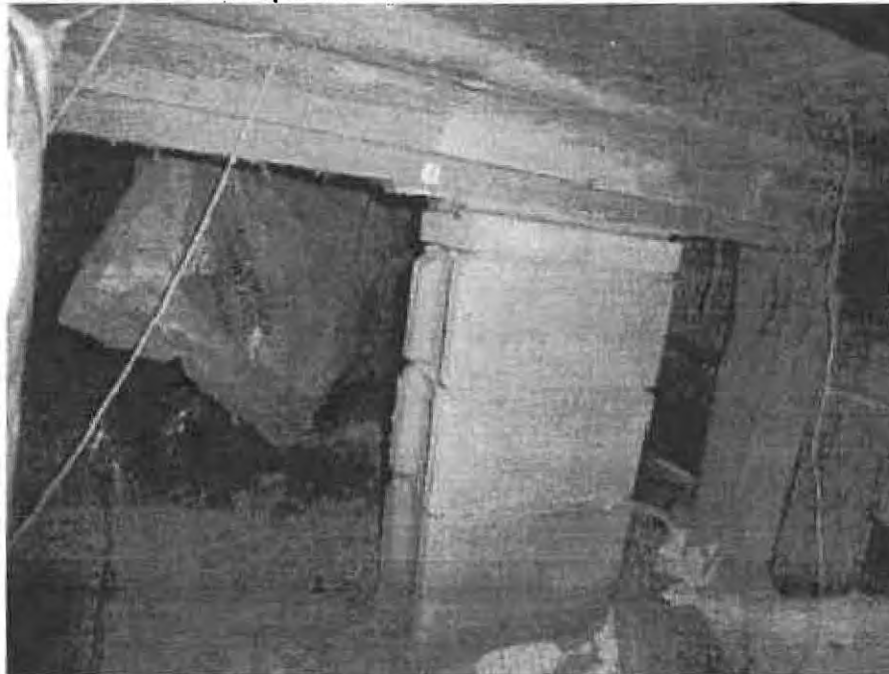
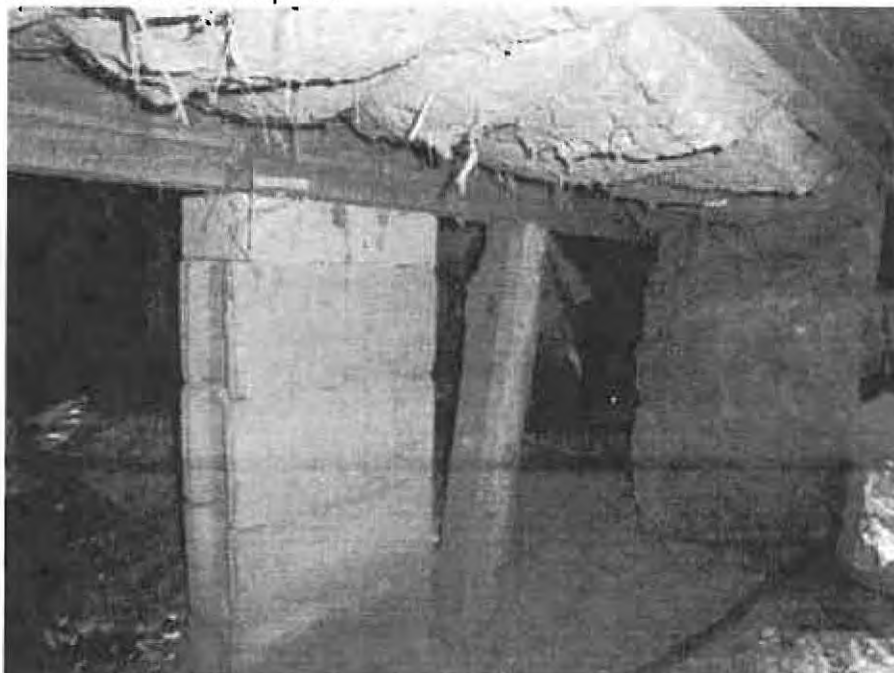
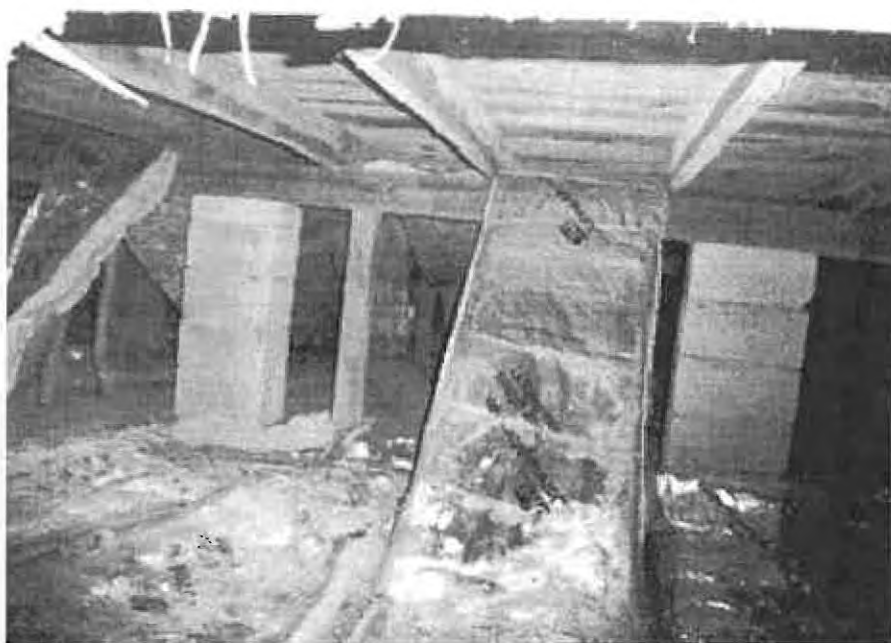
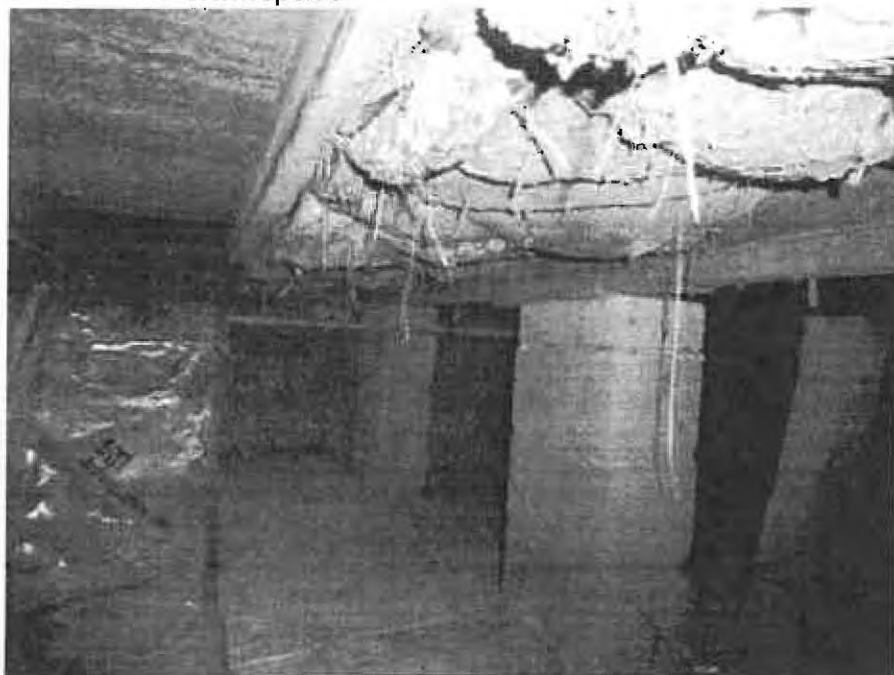
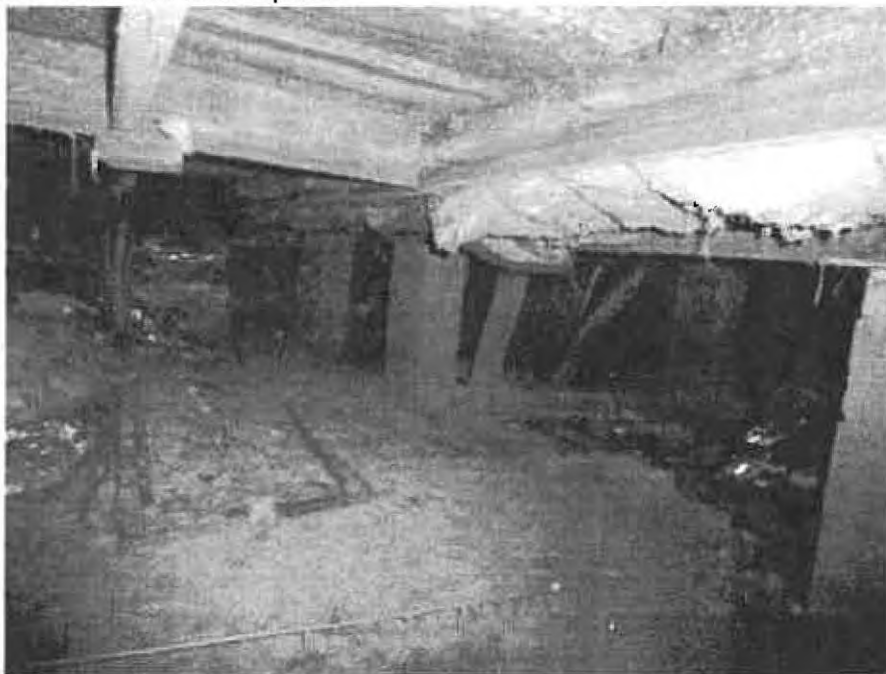
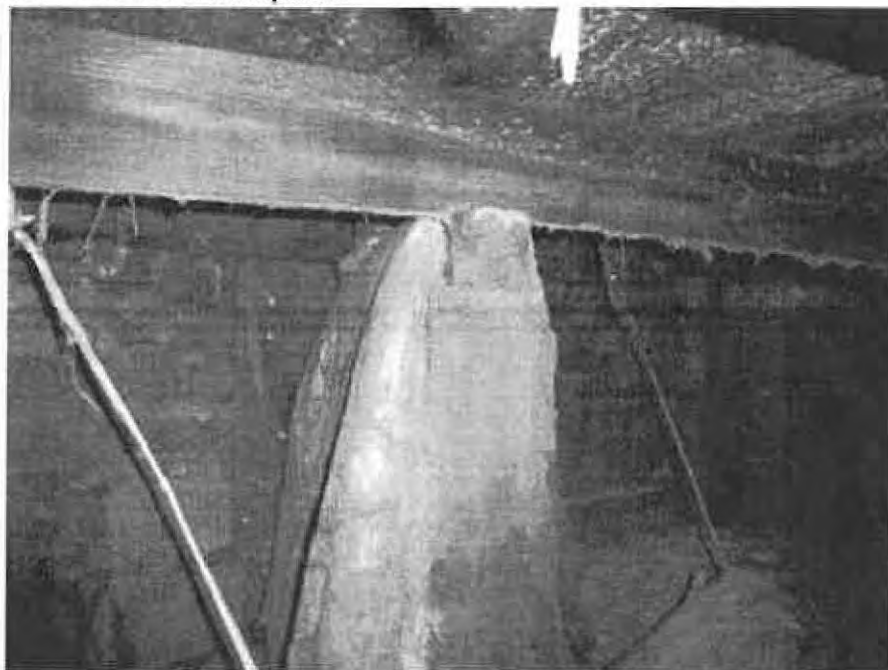
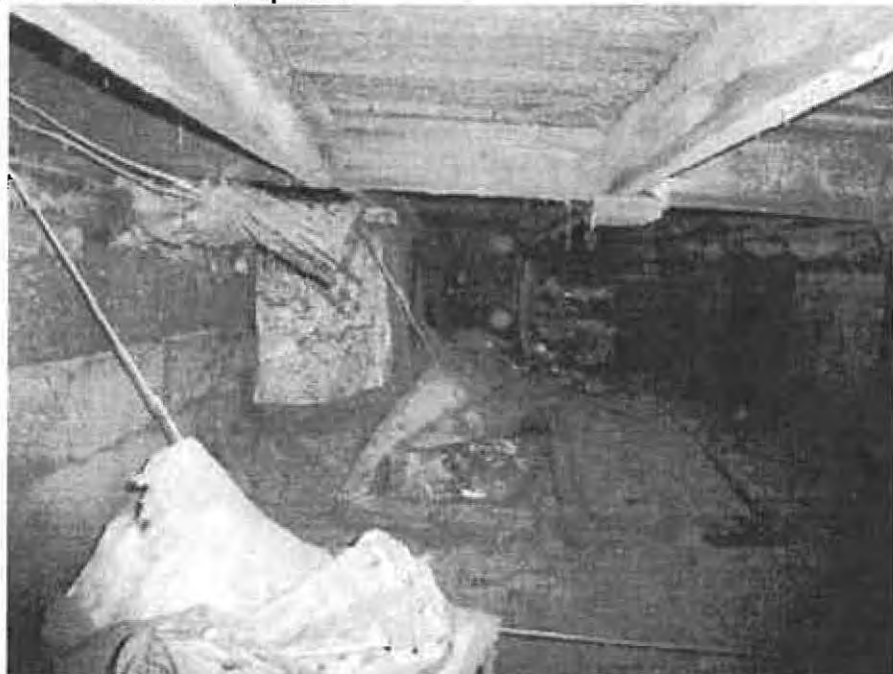
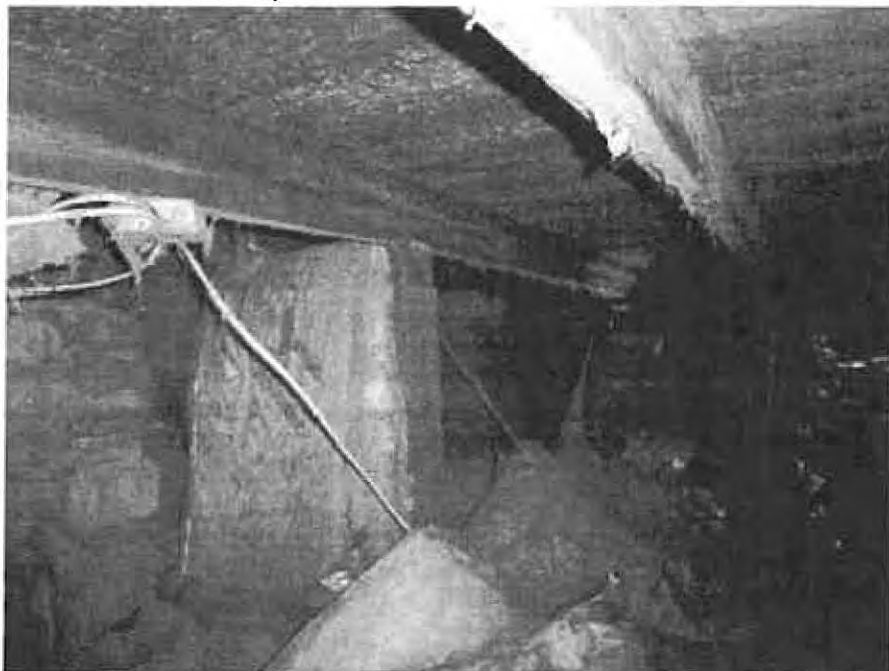
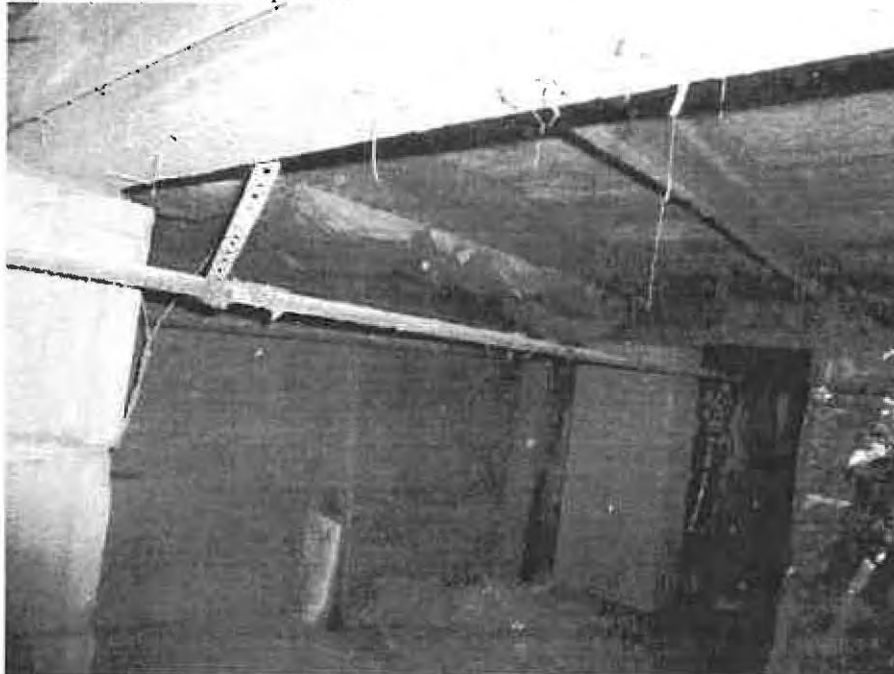
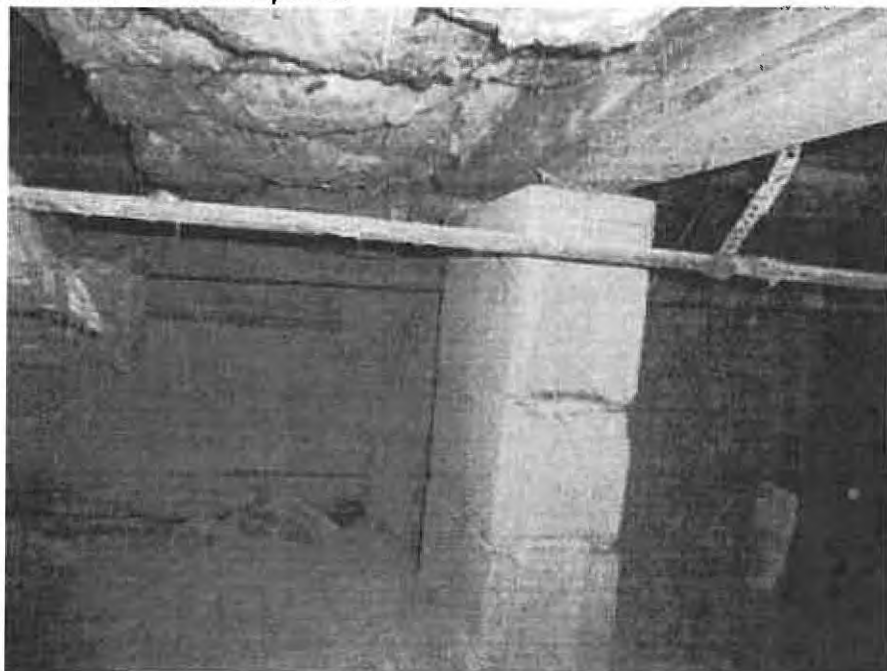
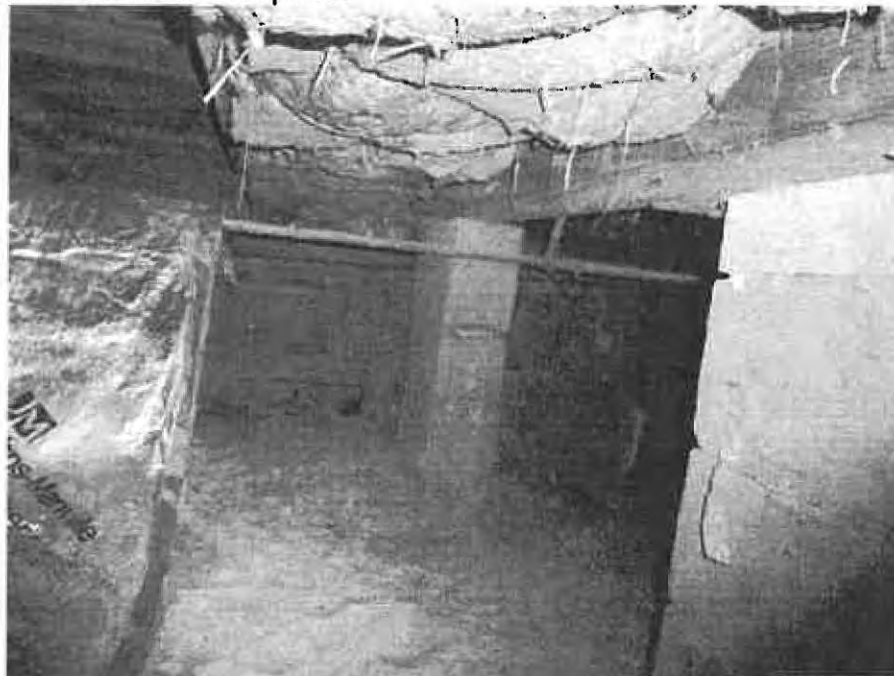
Some deposits of waterborne sand were observed in the crawlspace close to the south-west corner of the building.

We observed no evidence or indications of recent movement, distortion or shifting of the foundation system of the subject building consistent with the application of hydrodynamic forces or hydrostatic forces from floodwaters. No evidence of recent shifting or movement of the floor framing members or foundation components was observed beneath the subject building.

We observed deposits of waterborne sand inside the crawl space but we did not observe any erosion or scour of the soils inside the crawlspace or around the perimeter of the subject building or consistent with detrimental velocity flow.

Photograph 9
View from the crawlspace.
